Sunnyside Cogeneration Associates

RE: Fourth Quarter 2003 Inspection Report
Star Point Refuse Pile C/007/042

IMPOUNDMENT INSPECTION AND CERTIFIED REPORT		Sediment Pond 006	
Permit Number	C/007/042	Report Date 1/6/04	
Mine Name	STAR POINT WASTE FUEL		
Company Name	SUNNYSIDE COGENERATION ASSOCIATES		
Impoundment Identification	Impoundment Name	Sediment Pond 006	
	Impoundment Number	006	
	UPDES Permit Number	UTG040025	
	MSHA ID Number	N/A	
IMPOUNDMENT INSPECTION			
Inspection Date	December 12, 2003		
Inspected By	Scott Carlson		
Reason for Inspection (Annual, Quarterly or Other Periodic Inspection, Critical Installation, or Completion of Construction)		Fourth Quarter Inspection 2003	
<p>1. Describe any appearance of any instability, structural weakness, or any other hazardous condition.</p> <p>NONE</p>			
Required for an impoundment which functions as a SEDIMENTATION POND.	<p>2. Sediment storage capacity, including elevation of 60% and 100% sediment storage volumes, and, estimated average elevation of existing sediment.</p> <p>Total Pond volume = 2.6 acre-feet</p> <p>Sediment Storage Capacity = 0.76 acre-feet</p> <p>Pond bottom elevation = 7132.7</p> <p>60% sediment elevation = 7138

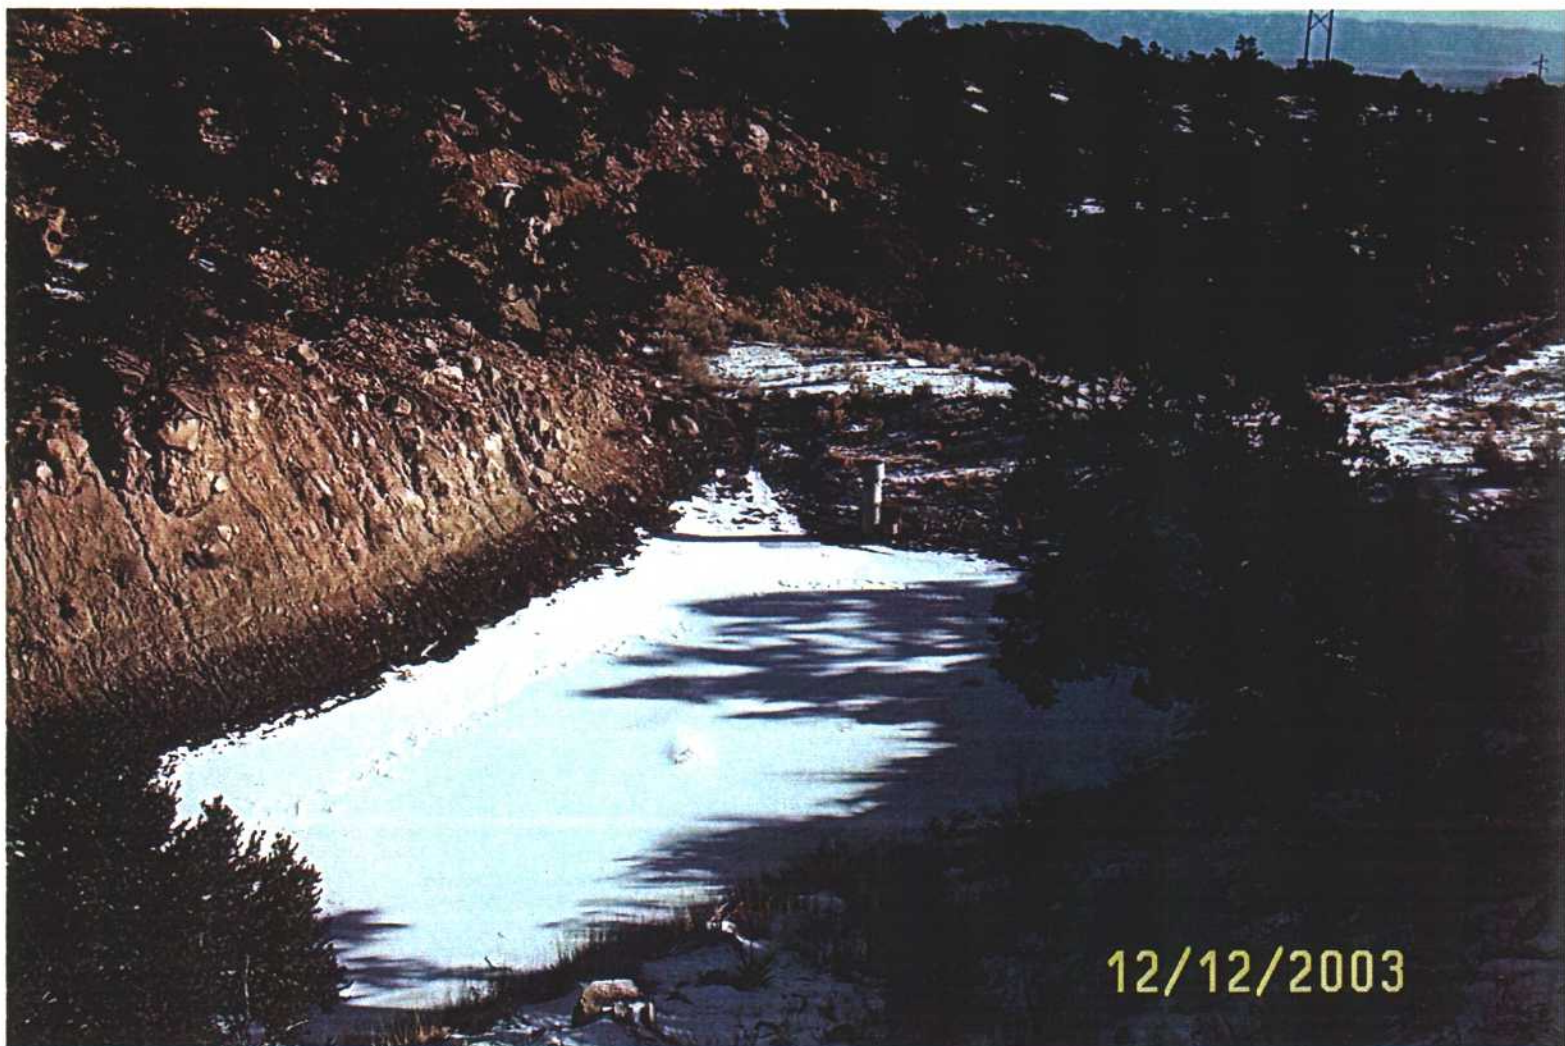
Sediment Pond # 006

No discharge, inlet/outlet conditions are good,
no structural or hazardous conditions exist.

No changes. Pond was essentially empty.
No structure or stability problems observed.

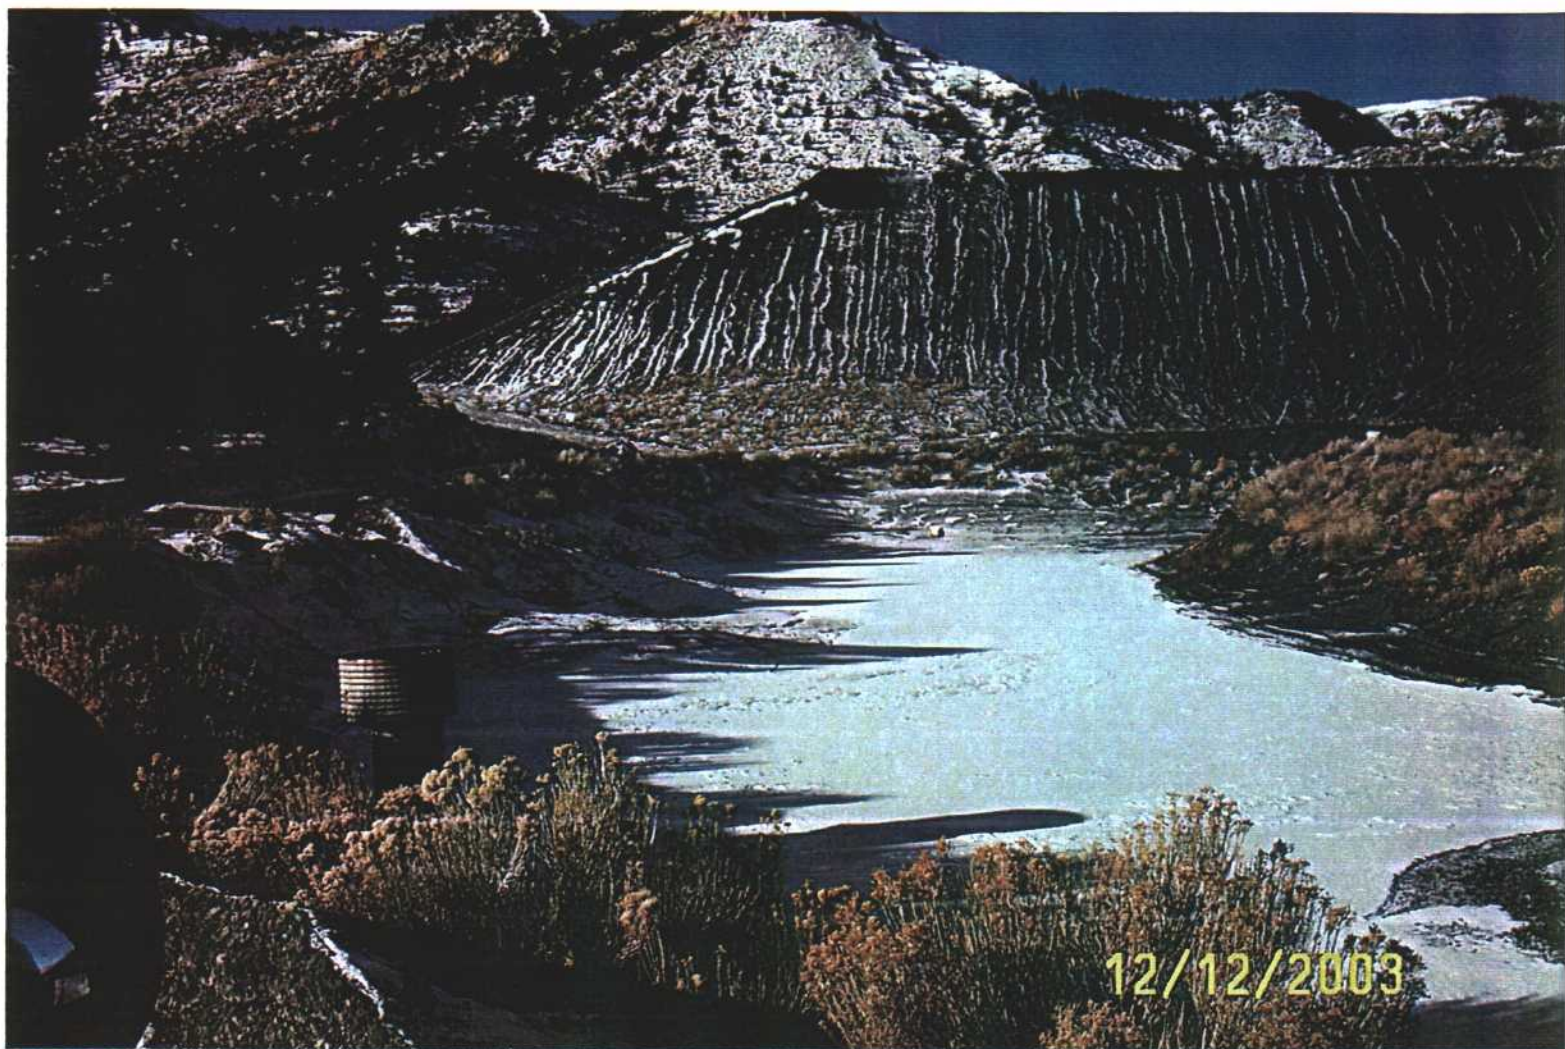
Sediment Pond # 005

No discharge, inlet/outlet conditions are good

No structural or hazardous conditions exist.

Pond was essentially empty.

No structure or stability problems observed.

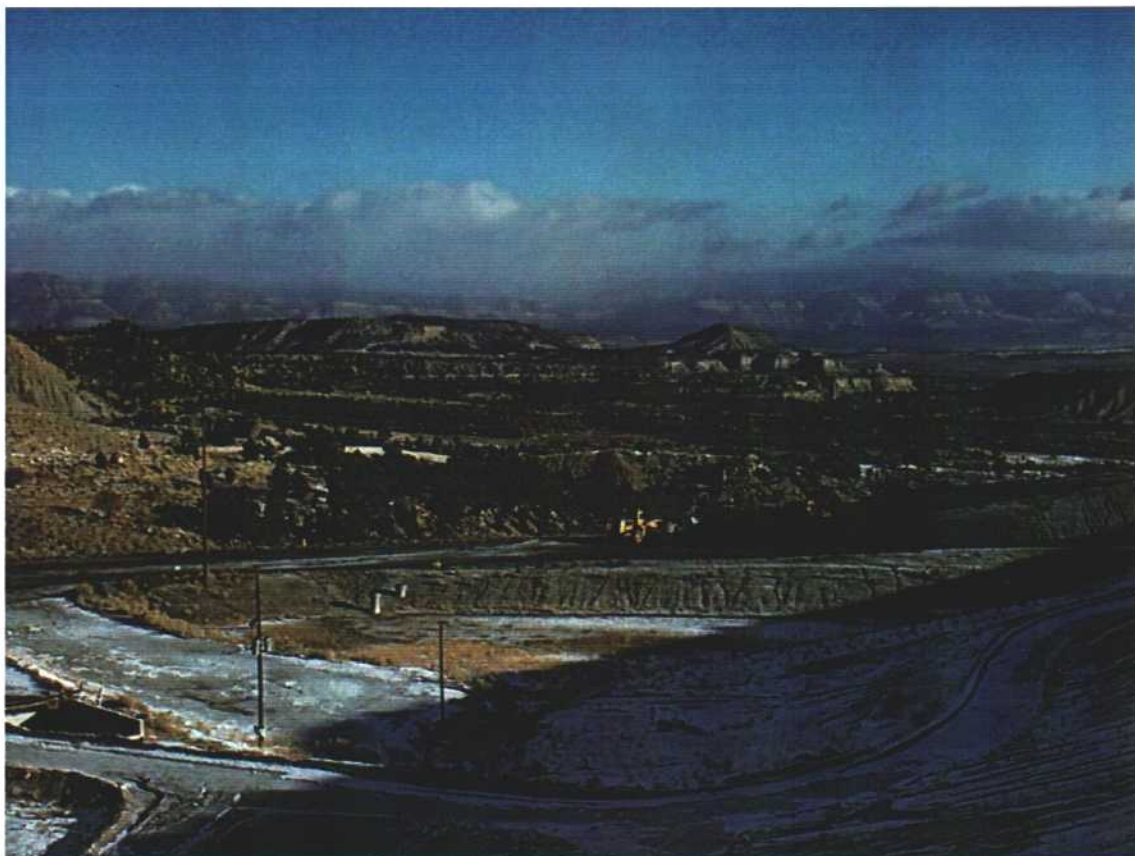
Sediment Pond 009 (12/12/03)

No discharge, Pond was essentially empty. inlet/outlet conditions are good,
No structural or hazardous conditions exist.

No changes, no structure or stability problems observed.

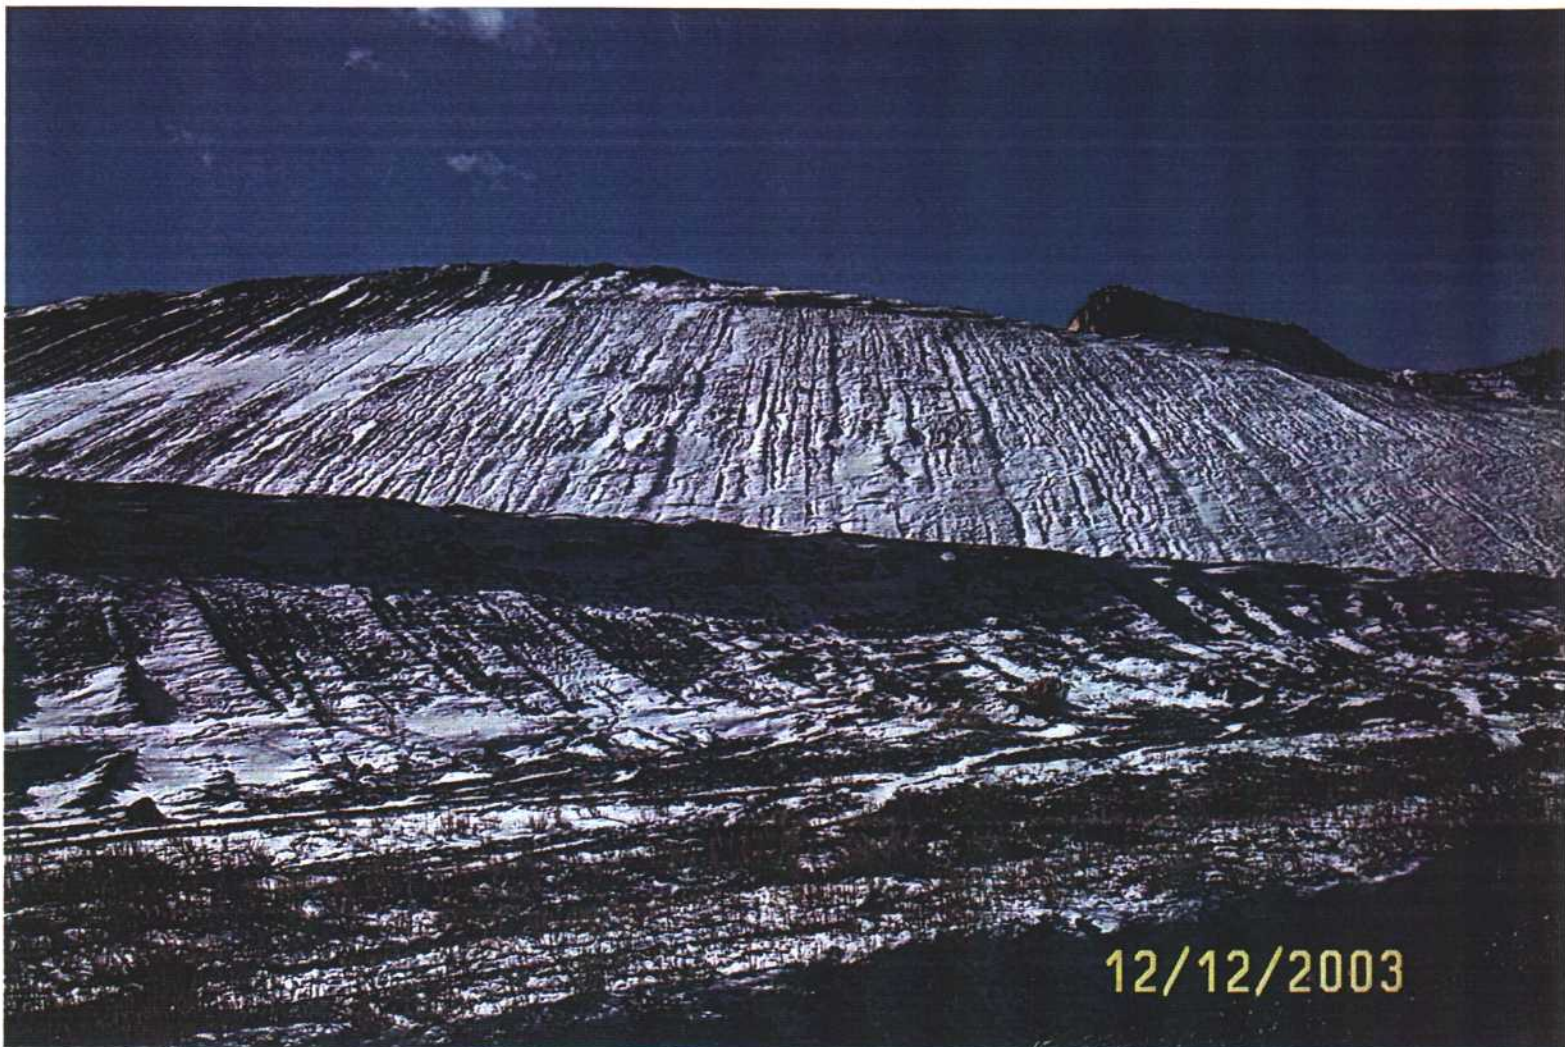
COARSE REFUSE PILE

INSPECTION AND CERTIFIED REPORT ON EXCESS SPOIL PILE OR REFUSE PILE	Coarse Refuse Pile
<p>5. Final grading and revegetation of fill.</p> <p>N/A</p>	
<p>6. Appearances of instability, structural weakness, and other hazardous conditions.</p> <p>No smokers visible</p> <p>Many small rills exist on the out slopes of the refuse pile. These have reportedly been there for some time and are typical for exposed refuse materials. They do not appear to pose a structural hazard. Runoff from the top surface is not directed to the out slope, therefore it is expected that re-grading would simply start new rills. Sediment from this erosion reports to existing sediment ponds. In time, SCA's operations to remove the pile will eliminate the problem.</p>	
<p>7. Other Comments. Describe any changes in the geometry of the Excess Spoil/Refuse Pile structure, instrumentation, average and maximum lifts of materials placed in the pile, elevations of active benches, total and remaining storage capacity of the structure, evidence of fires in the pile and abatement of such fires, volumes of materials placed in the structure during the year, and any other aspect of the structure affecting its stability or function which has occurred during the reporting period.</p> <p>Waste Coal Removal</p>

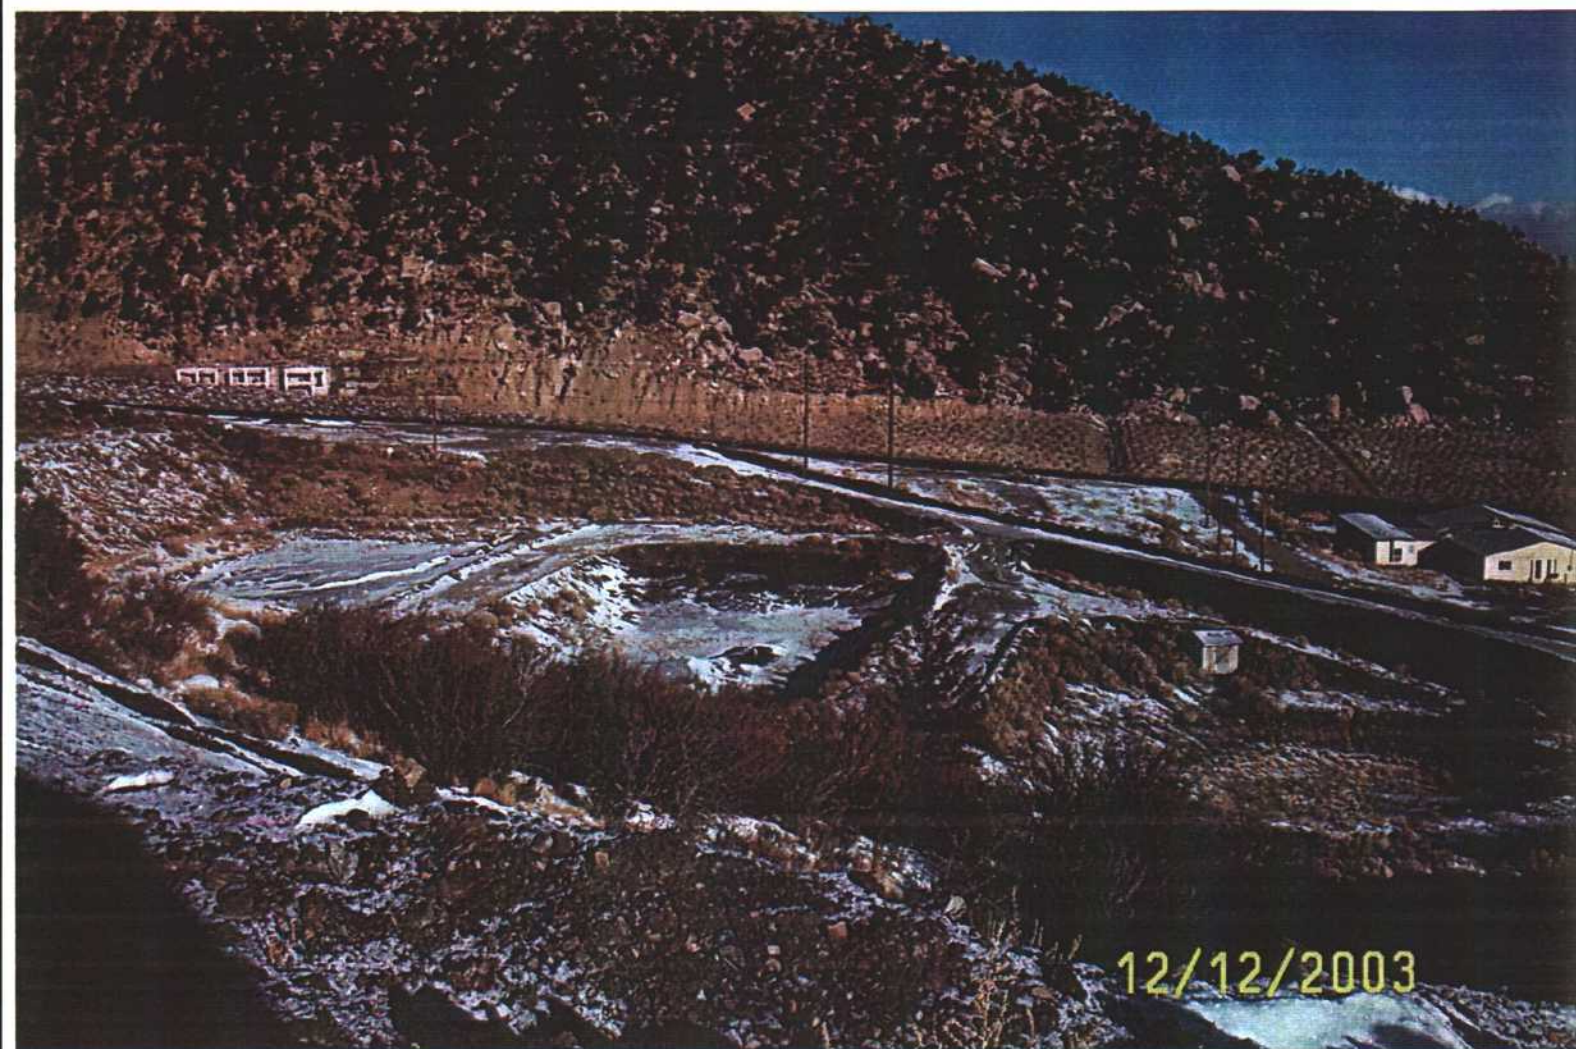
Site of Proposed DISPOSAL AREA

<p>3. Installation of final surface drainage systems.</p> <p>N/A</p>			
<p>4. Placement and compaction of fill materials.</p> <p>Did not receive disposal materials during this Quarter.</p>

INSPECTION AND CERTIFIED REPORT ON EXCESS SPOIL PILE OR REFUSE PILE	Disposal Area	
<p>5. Final grading and revegetation of fill.</p> <p>N/A</p>		
<p>6. Appearances of instability, structural weakness, and other hazardous conditions.</p> <p>None</p>		
<p>7. Other Comments. Describe any changes in the geometry of the Excess Spoil/Refuse Pile structure, instrumentation, average and maximum lifts of materials placed in the pile, elevations of active benches, total and remaining storage capacity of the structure, evidence of fires in the pile and abatement of such fires, volumes of materials placed in the structure during the year, and any other aspect of the structure affecting its stability or function which has occurred during the reporting period.</p> <p>No Construction occurred during this quarter.</p>		
<p>Certification Statement</p>	<p>I hereby certify that; I am experienced in the construction of earth and rock fills; I am qualified and authorized in the State of Utah to inspect and certify the condition and appearance of earth and rock fills in accordance with the certified and approved designs for this structure; that the fill structure has been maintained in accordance with approved design and meet or exceed the minimum design requirements under all applicable federal, state and local regulations; and, that inspections and inspection reports are made by myself and include any appearances of instability, structural weakness or other hazardous conditions of the structure affecting stability.</p> <p>By: <u>S. Scott Carlson - Senior Project Manager</u></p> <p>(Full Name and Title)</p> <p>Signature: <u><i>S. Scott Carlson</i></u></p> <p>P.E. Number & State: <u>187727 - U</u></p>
